Engine Bearing Failure Analysis Guide

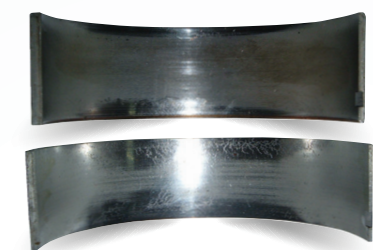
Imperfect Journal Geometry

Localized wear in parts of the bearing surface. Fatigue cracks may occur in these areas.

- Inconsistent journal diameter. Areas of greater diameter produce metal-to-metal contact with the bearing surface, causing local wear
- Use of worn or improperly dressed grinding wheel when resizing the crankshaft. Journals may result as tapered, hourglass shape or barrel shape

- Replace/redress grinding wheel
- Re-grind the crankshaft

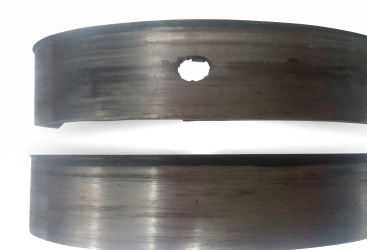
Spinning of the Bearing in the Housing

Highly polished area on the bearing back caused by bearing spinning in the housing.

- Insufficient crush height
- Oil starvation/lugging the engine causing seizure
- Housing diameter greater than specified value

- Choose bearings with sufficient crush height for the application
- Eliminate the cause of seizure
- Check housing diameter for size and roundness
- Tighten bolts to the specified torque value
